**Flood Control Project Maintenance  
Levee Inspections**  
**LMA District Cover Sheet**  
**Spring 2017 Levee Inspection Results**

**Reclamation District No. 0999 Netherlands**

**Spring 2017 Levee Inspection Results**

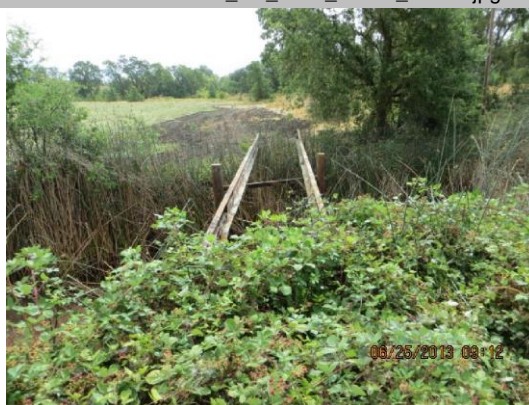
Photo 2 of 3 : UCIP\_SP\_2017\_50092\_25190.jpg

Pump platform visible off LS toe, but no appurtances remain.

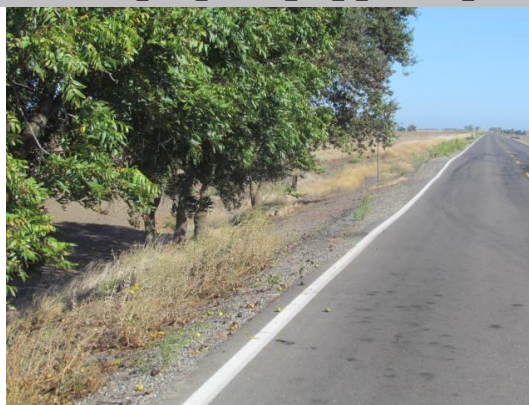
Photo 1 of 2 : SP\_2017\_RD0999\_232\_4\_20170314\_00011.jpg

Looking northwest at trimmed trees on waterward slope.

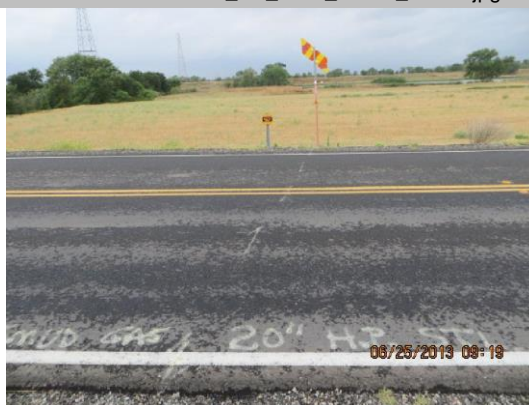
Photo 1 of 2 : UCIP\_SP\_2017\_16324\_27501.jpg

Gasline markers on WS shoulder with USAA paint on roadway.

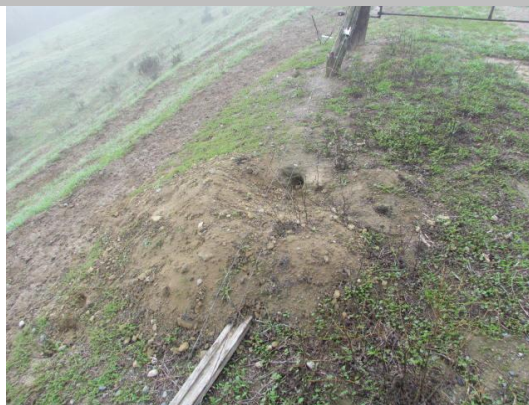
Photo 5 of 5 : SP\_2017\_RD0999\_232\_2\_20170314\_00010.jpg

Looking south at rodent hole on landside shoulder. (Fall 2014)

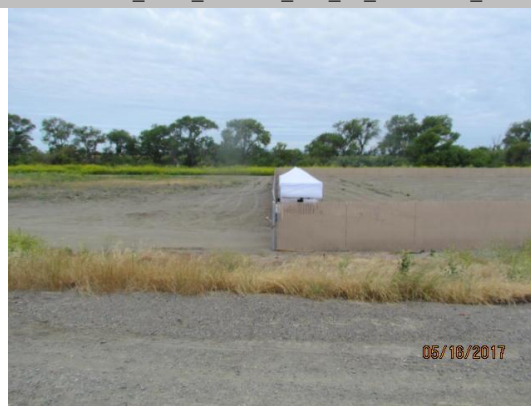
Photo 2 of 2 : SP\_2017\_RD0999\_232\_74\_20170516\_00115.jpg

New fence looking west (Spring 2017)

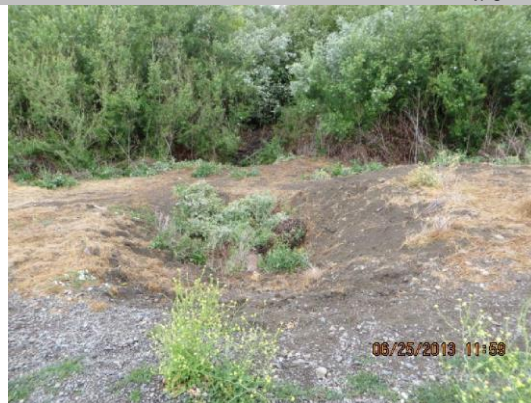
Photo 1 of 3 : UCIP\_SP\_2017\_50097\_25415.jpg

Pipe visible in exposed cut on WS slope.

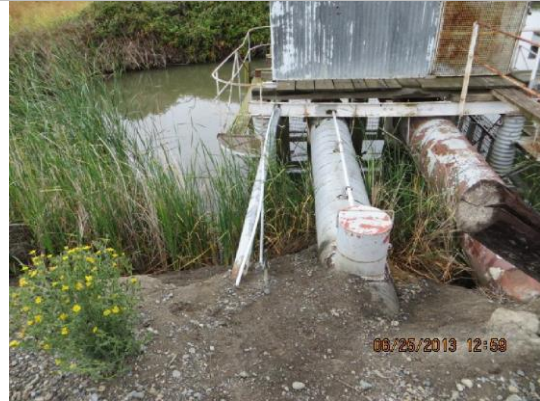
Photo 3 of 3 : UCIP\_SP\_2017\_15366\_25229.jpg

Closeup of 24-inch pipe on LS toe.

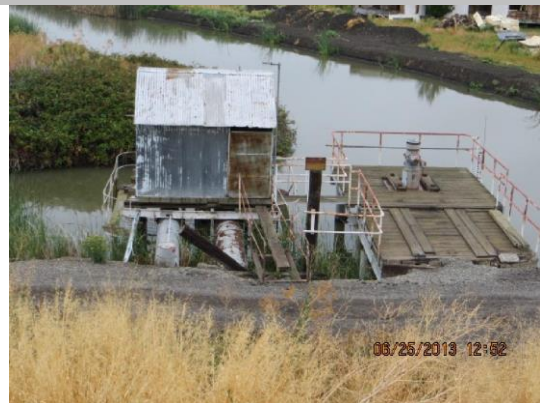
Photo 1 of 3 : UCIP\_SP\_2017\_15365\_25227.jpg

Pumphouse on LS toe.

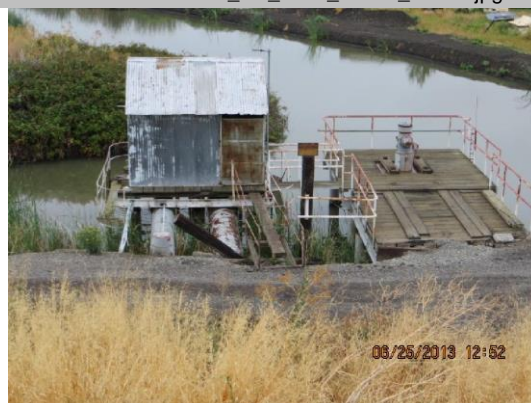
Photo 1 of 3 : UCIP\_SP\_2017\_15363\_25219.jpg

Pump platform to right of pumphouse.

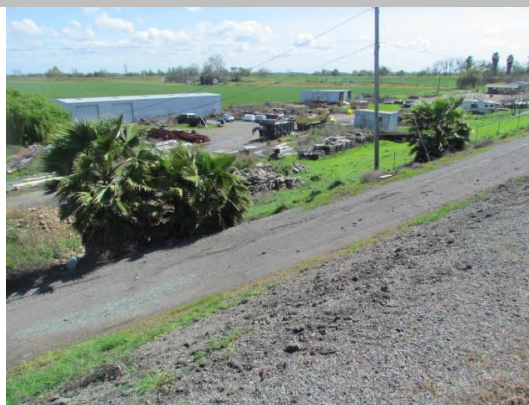
Photo 1 of 2 : SP\_2017\_RD0999\_232\_44\_20170314\_00046.jpg

Looking east at palm trees on landward slope next to ramp.

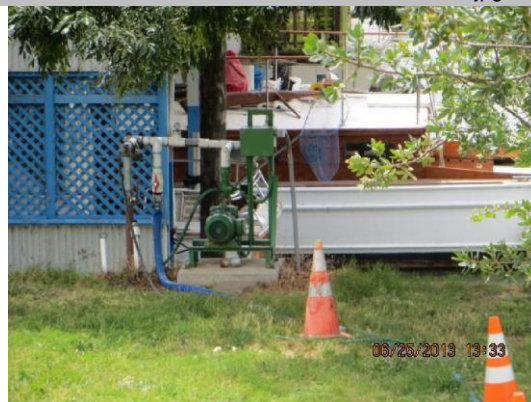
Photo 2 of 3 : UCIP\_SP\_2017\_16330\_27511.jpg

Possible pump visible off WS toe at waters edge.

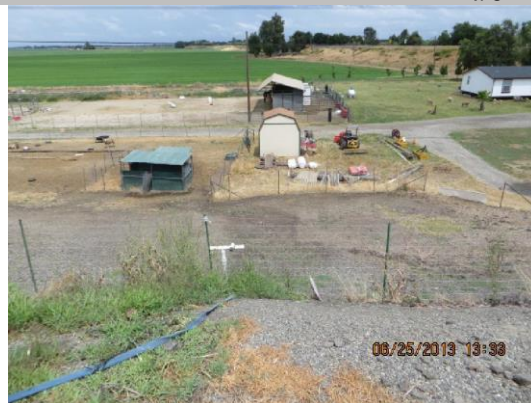
Photo 3 of 3 : UCIP\_SP\_2017\_16330\_27510.jpg

Pipe visible on LS toe.

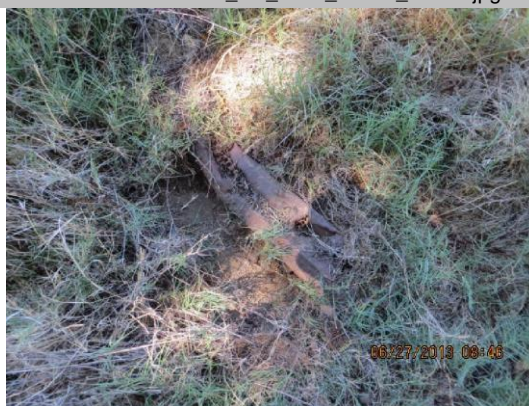
Photo 3 of 3 : UCIP\_SP\_2017\_15384\_25240.jpg

Damaged pipe on LS slope.

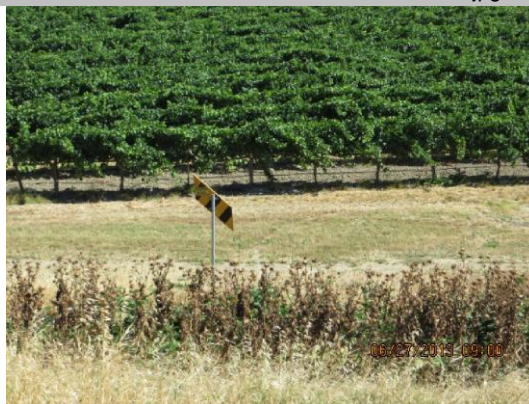
Photo 2 of 3 : UCIP\_SP\_2017\_16331\_27515.jpg

Gasline marker on LS toe.

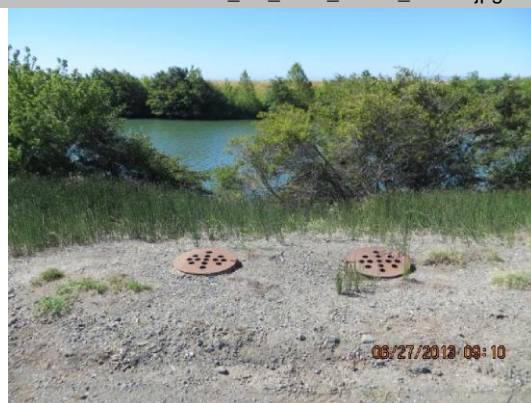
Photo 1 of 3 : UCIP\_SP\_2017\_16334\_27527.jpg

Siphon breaker on WS shoulder.

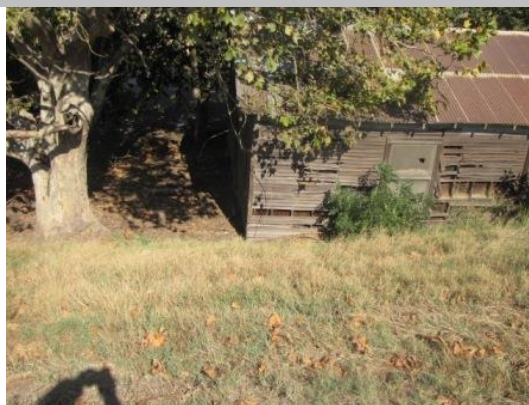
Photo 1 of 2 : SP\_2017\_RD0999\_233\_3\_20170314\_00005.jpg

Looking North at building at landside toe.

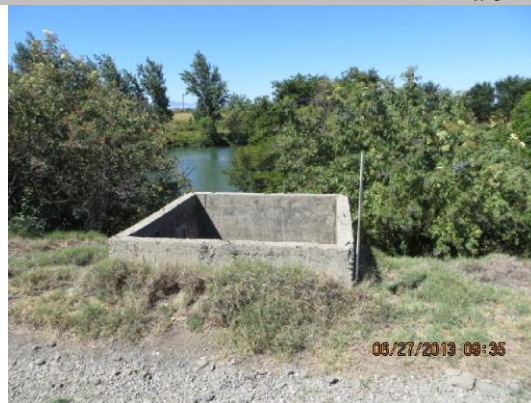
Photo 1 of 2 : UCIP\_SP\_2017\_41069\_25251.jpg

7'X7' concrete pumphouse sump on WS shoulder.

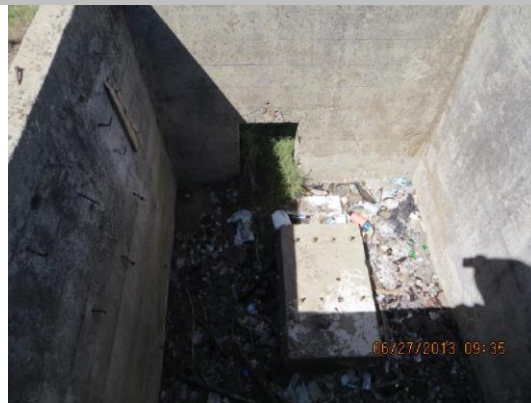
Photo 2 of 2 : UCIP\_SP\_2017\_41069\_25250.jpg

Pump mount inside foundation at WS slope.

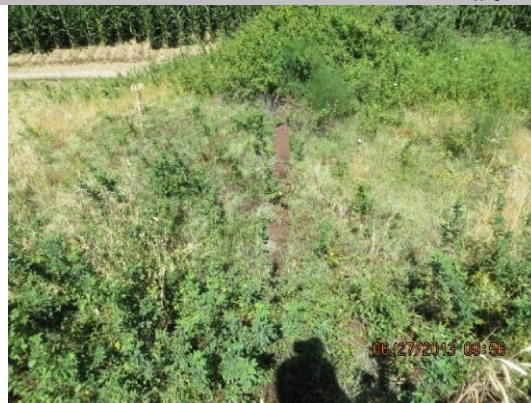
Photo 2 of 3 : UCIP\_SP\_2017\_15389\_25253.jpg

Pipe visible on LS slope.

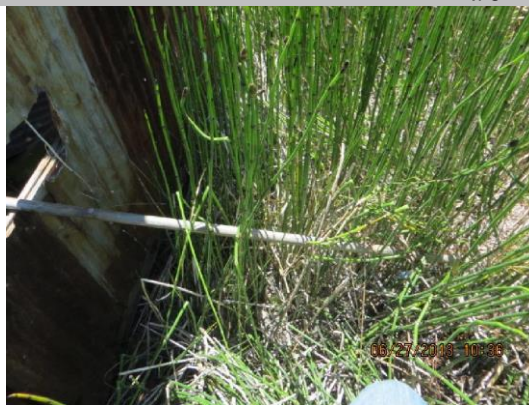
Photo 2 of 3 : UCIP\_SP\_2017\_15392\_25260.jpg

1-inch galvanized iron electrical conduit on WS slope.

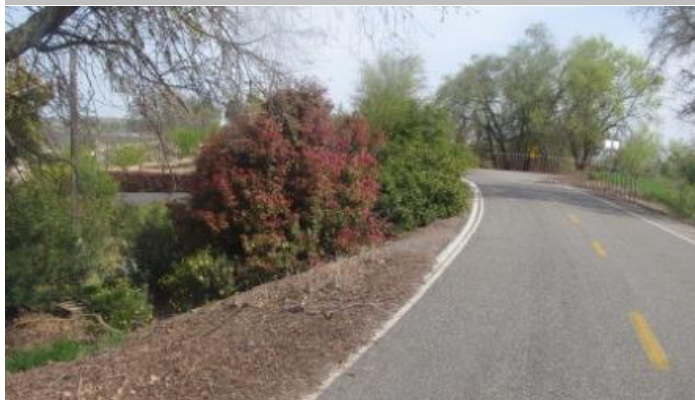
Photo 2 of 2 : SP\_2017\_RD0999\_234\_22\_20170314\_00020.jpg

Looking northwest at landscaping on landside slope and toe. (Spring 2011)

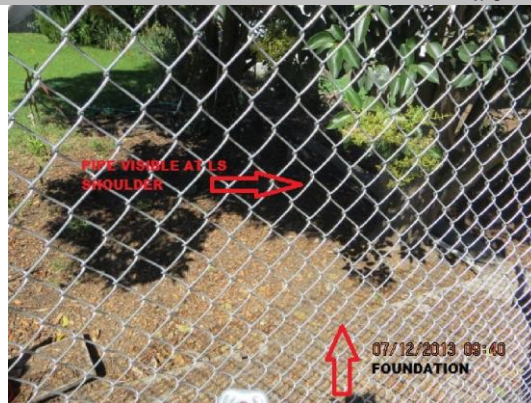
Photo 1 of 3 : UCIP\_SP\_2017\_15709\_26140.jpg

Pipe visible at concrete foundation on LS shoulder.

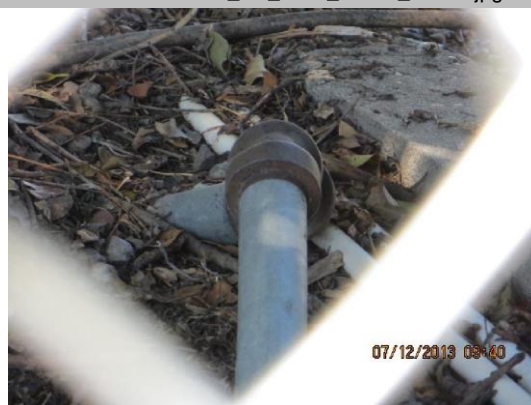
Photo 2 of 3 : UCIP\_SP\_2017\_15709\_26139.jpg

Pipe visible at concrete foundation on LS shoulder.

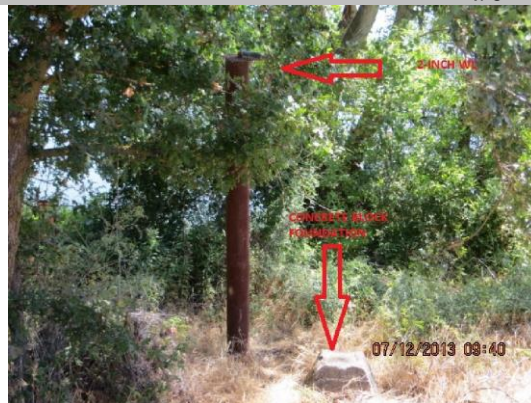
Photo 3 of 3 : UCIP\_SP\_2017\_15709\_26138.jpg

Pipe visible at top of steel standpipe. Foundation for pump station visible on WS slope.

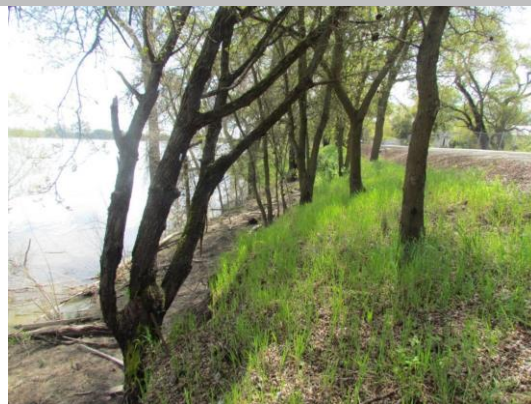
Photo 1 of 2 : SP\_2017\_RD0999\_235\_15\_20170324\_00074.jpg

Looking downstream at 2ft plus vertical erosion on waterward slope.

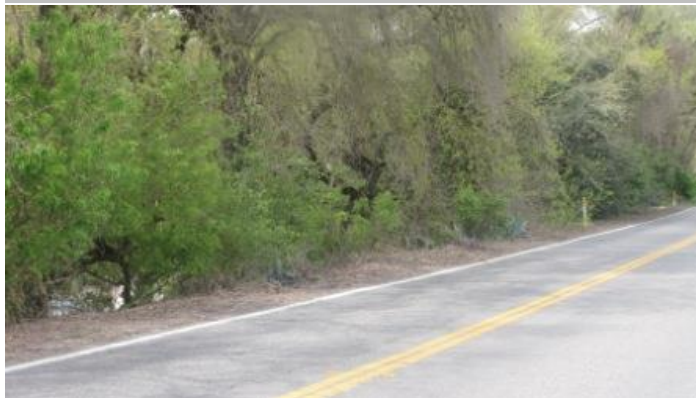
Photo 2 of 2 : SP\_2017\_RD0999\_235\_10\_20170314\_00007.jpg

Looking west at dense trees on waterside slope.

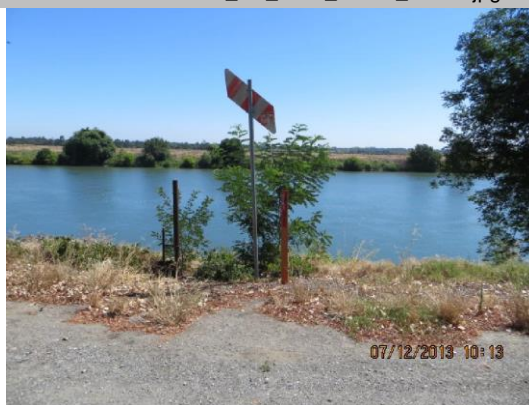
Photo 1 of 3 : UCIP\_SP\_2017\_15712\_26150.jpg

Air vent in standpipe on WS shoulder.

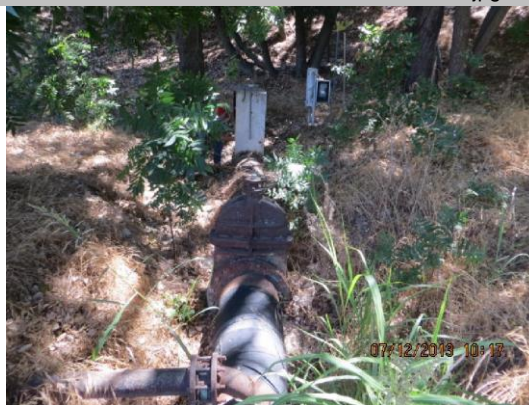
Photo 3 of 3 : UCIP\_SP\_2017\_15712\_26148.jpg

Gate valve on LS toe.

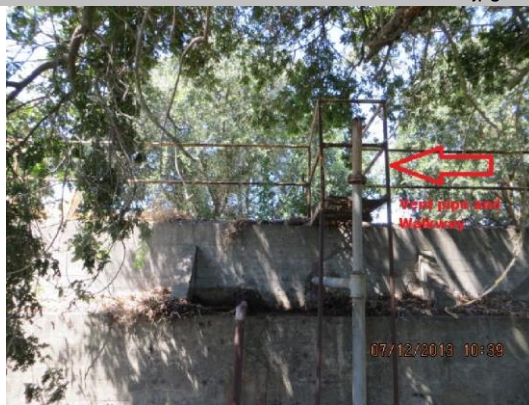
Photo 2 of 3 : UCIP\_SP\_2017\_41070\_26173.jpg

Pipe, walkway, and vent on WS shoulder.

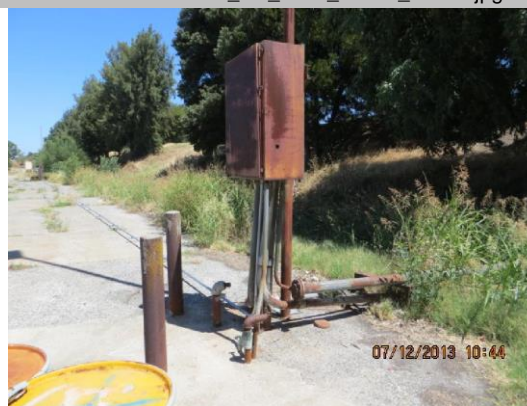
Photo 3 of 3 : UCIP\_SP\_2017\_41070\_26175.jpg

Pipe with cap or gate valve on end off LS toe.

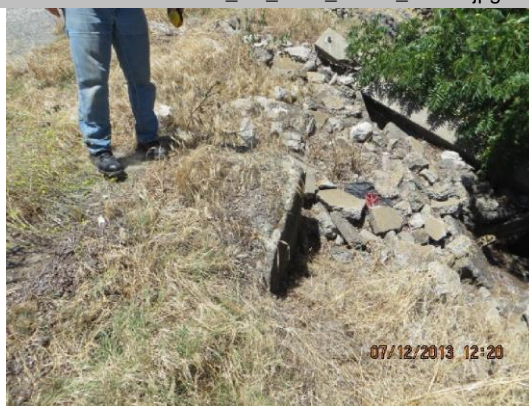
Photo 3 of 3 : UCIP\_SP\_2017\_16385\_27653.jpg

Pipe assumed to be in concrete vault on WS shoulder.

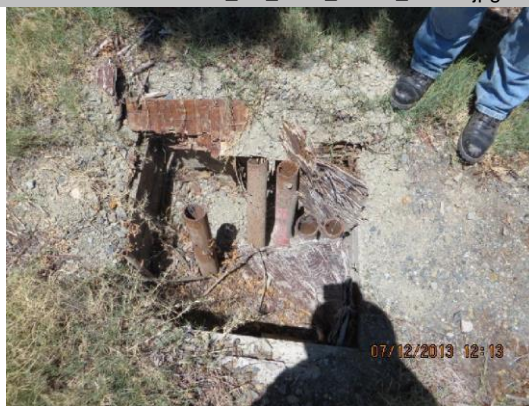
Photo 1 of 3 : UCIP\_SP\_2017\_16386\_27661.jpg

Pipes visible in concrete well on LS shoulder.

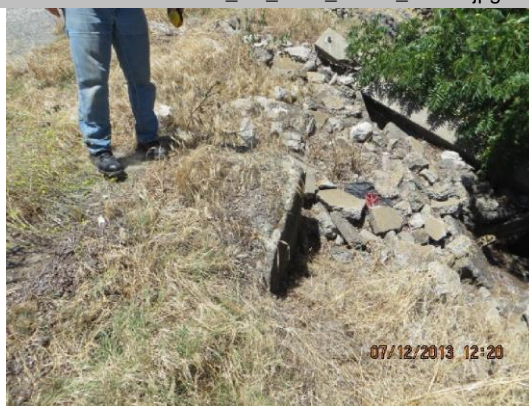
Photo 3 of 3 : UCIP\_SP\_2017\_15728\_26187.jpg

Assumed pipes are in concrete well on WS shoulder at same location.

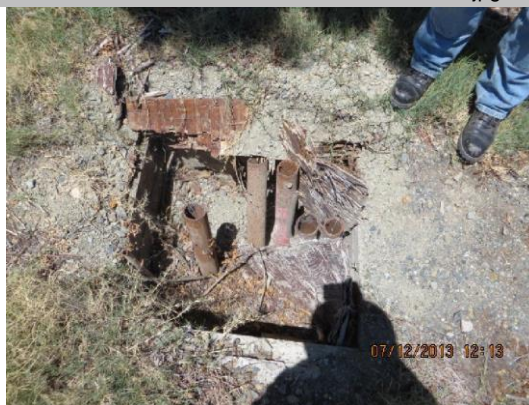
Photo 1 of 3 : UCIP\_SP\_2017\_15727\_26186.jpg

Pipes in concrete well on LS shoulder.

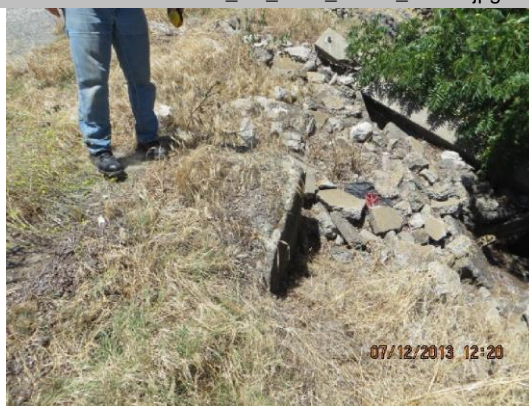
Photo 3 of 3 : UCIP\_SP\_2017\_16384\_27647.jpg

Pipe assumed to be in concrete well on WS shoulder.

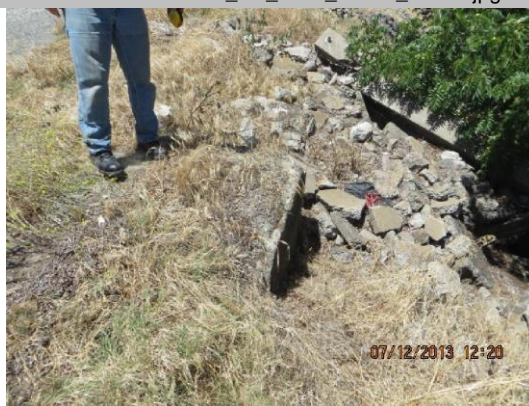
Photo 3 of 3 : UCIP\_SP\_2017\_15733\_26195.jpg

Pipe assumed visible in concrete well on WS shoulder.

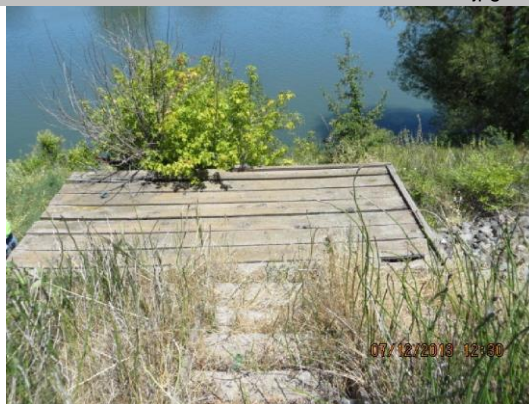
Photo 3 of 3 : UCIP\_SP\_2017\_16387\_27662.jpg

9'X18' concrete box with gate valve on WS slope.

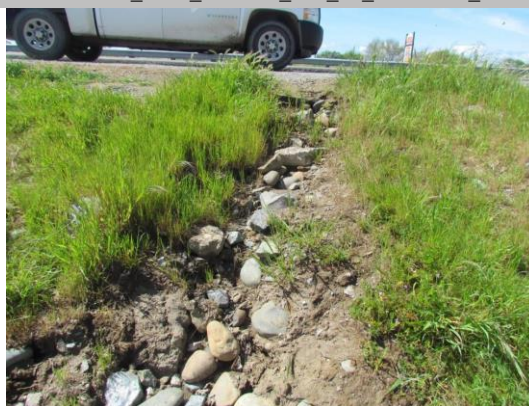
Photo 1 of 1 : SP\_2017\_RD0999\_235\_48\_20170324\_00078.jpg

Looking west at runoff erosion on waterward slope.

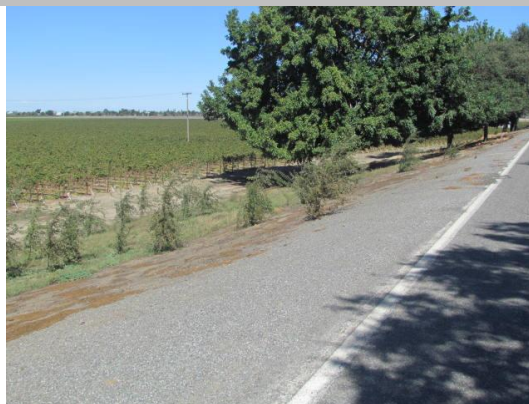
Photo 1 of 1 : SP\_2017\_RD0999\_236\_72\_20170314\_00060.jpg

Looking west at small oak trees on landward slope.

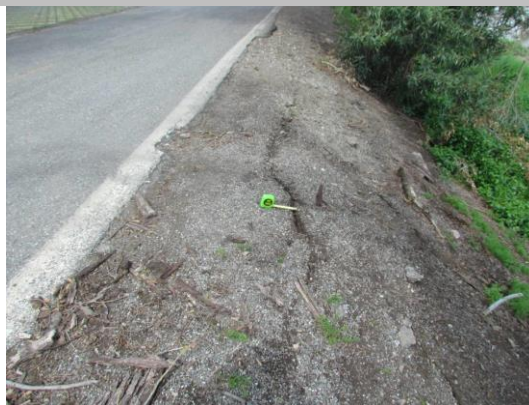
Photo 2 of 3 : SP\_2017\_RD0999\_236\_165\_20170324\_00233.jpg

Looking upstream at cracking along waterward shoulder.

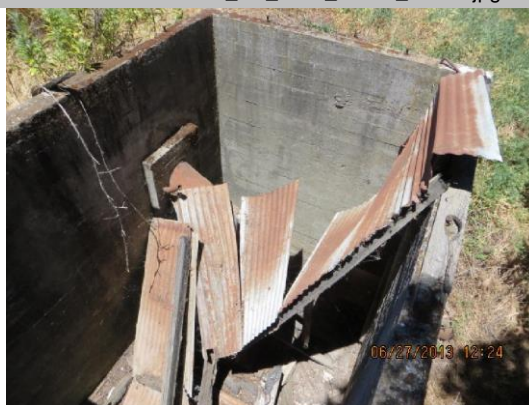
Photo 1 of 3 : UCIP\_SP\_2017\_15414\_25308.jpg

Pipe visible inside abandoned pumphouse on WS slope.

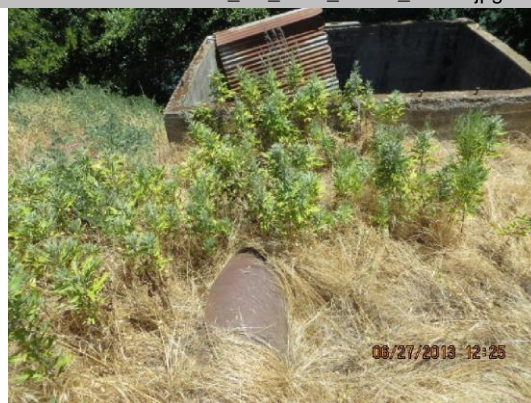
Photo 2 of 3 : UCIP\_SP\_2017\_15414\_25307.jpg

Pipe visible on WS slope.

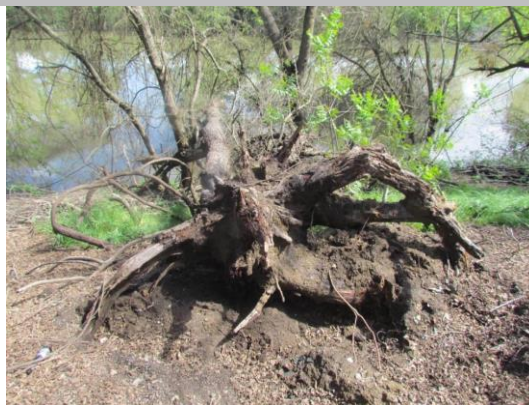
Photo 3 of 3 : SP\_2017\_RD0999\_236\_166\_20170324\_00237.jpg

Looking downstream at fallen tree on waterward slope.

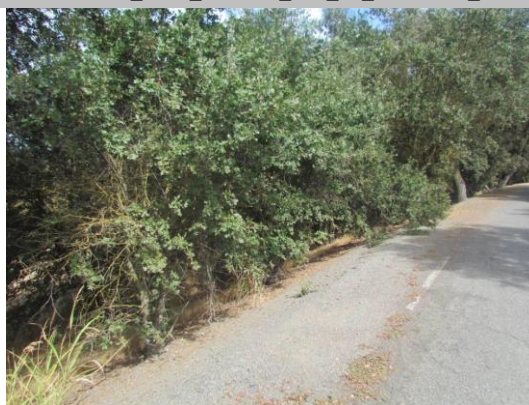
Photo 1 of 1 : SP\_2017\_RD0999\_236\_14\_20170314\_00015.jpg

Looking west at untrimmed trees on landward slope and toe.

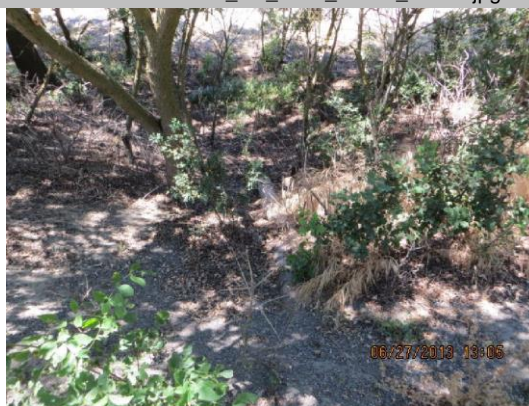
Photo 2 of 2 : UCIP\_SP\_2017\_15421\_25322.jpg

Pipe visible on LS slope.

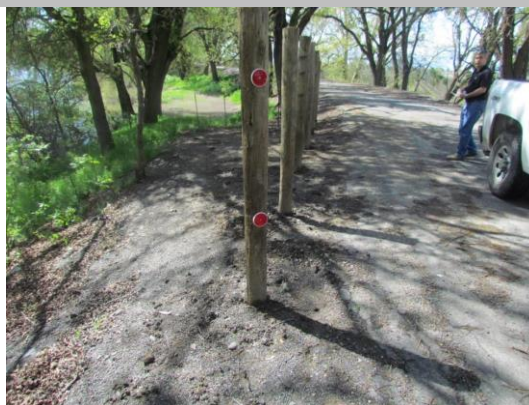
Photo 1 of 3 : SP\_2017\_RD0999\_236\_167\_20170324\_00238.jpg

Looking downstream at wooden poles on waterward shoulder.

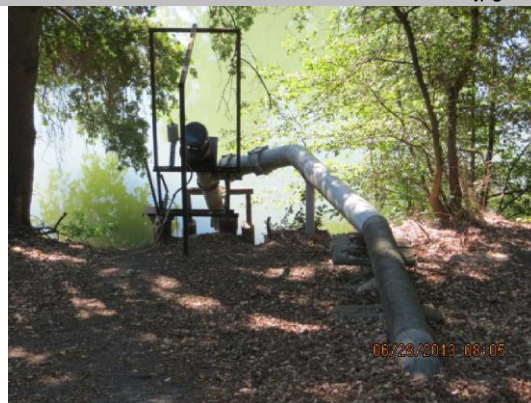
Photo 2 of 3 : UCIP\_SP\_2017\_50093\_25331.jpg

Slant pump and pipe on WS slope.

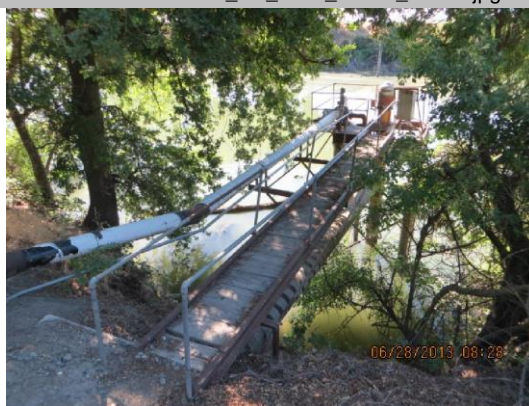
Photo 1 of 3 : UCIP\_SP\_2017\_16337\_27535.jpg

Pump on pier at WS.

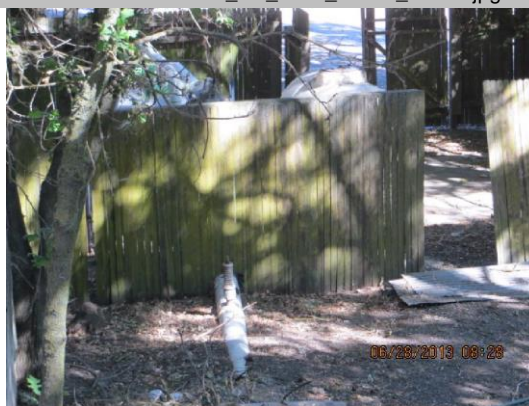
Photo 3 of 3 : UCIP\_SP\_2017\_16337\_27533.jpg

Siphon breaker and filter plant on LS toe.

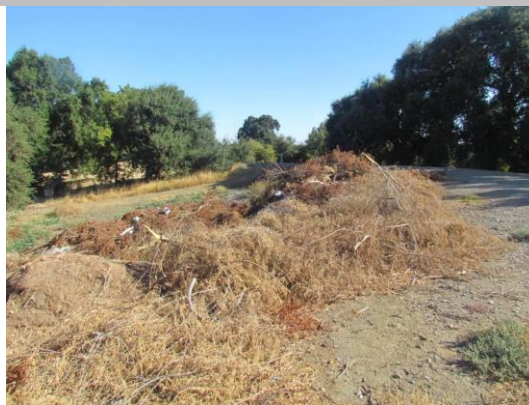
Photo 2 of 2 : SP\_2017\_RD0999\_236\_17\_20170314\_00019.jpg

Looking northwest at large pruning pile on landward slope. (Fall 2016)

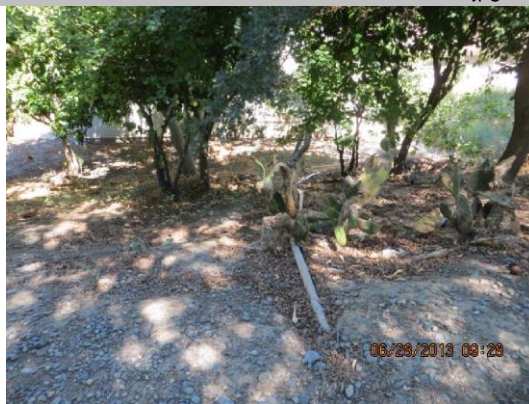
Photo 2 of 2 : UCIP\_SP\_2017\_16338\_27537.jpg

Flex pipe visible on LS shoulder.

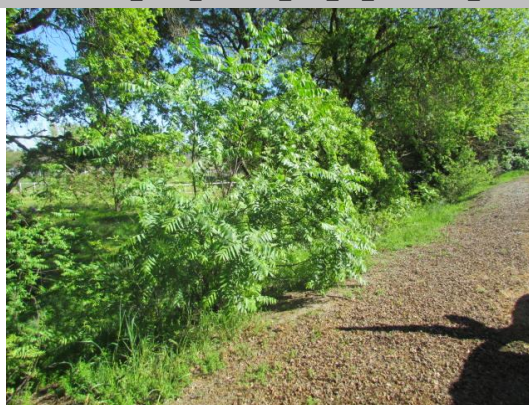
Photo 1 of 1 : SP\_2017\_RD0999\_236\_57\_20170314\_00050.jpg

Looking northwest at dense trees on landward slope. (Spring 2015)

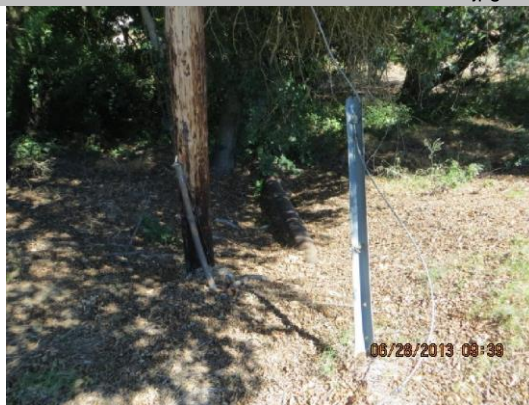
Photo 3 of 3 : UCIP\_SP\_2017\_15443\_25360.jpg

Pipe visible on LS slope.

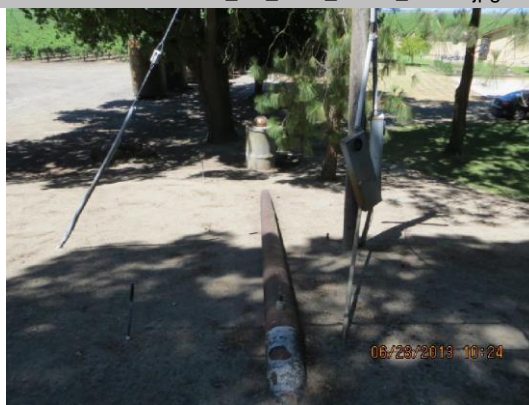
Photo 1 of 3 : UCIP\_SP\_2017\_15446\_25366.jpg

Pipe visible on LS slope with JP, Meter and electrical conduit, and concrete standpipe,

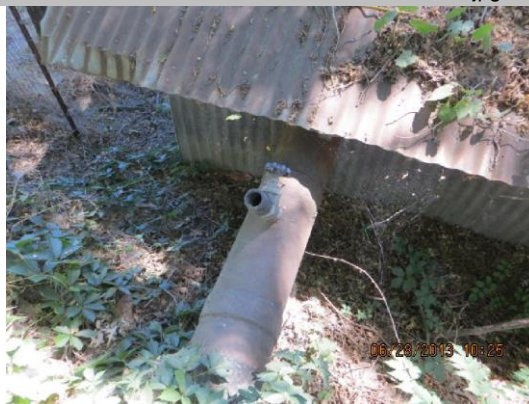
Photo 3 of 3 : UCIP\_SP\_2017\_15446\_25364.jpg

Vent on pipe at WS shoulder.

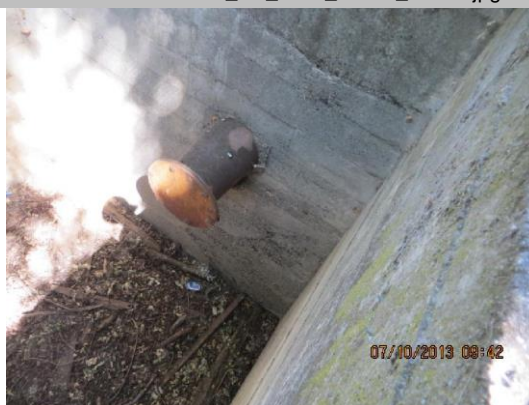
Photo 1 of 2 : UCIP\_SP\_2017\_15604\_25875.jpg

Pipe with steel plate bolted over opening at concrete pump pit on WS toe.

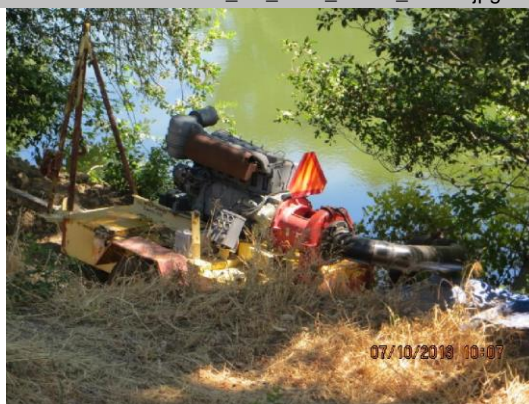
Photo 2 of 2 : UCIP\_SP\_2017\_16342\_27543.jpg

Portable pump on WS toe.

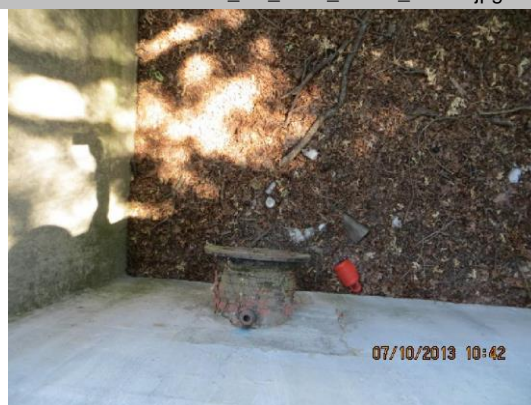
Photo 3 of 3 : UCIP\_SP\_2017\_50096\_25936.jpg

Pipe open at pump pit on WS toe.

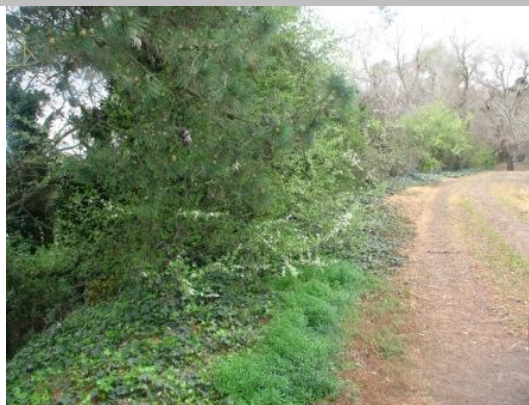
Photo 2 of 2 : SP\_2017\_RD0999\_236\_66\_20170314\_00055.jpg

Landscaping on landside slope blocking view of slope. (Spring 2016)

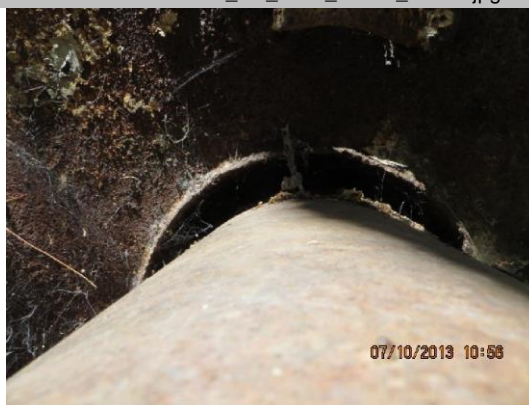
Photo 2 of 3 : UCIP\_SP\_2017\_15624\_25968.jpg

Notice: No grout between sleeved pipes.

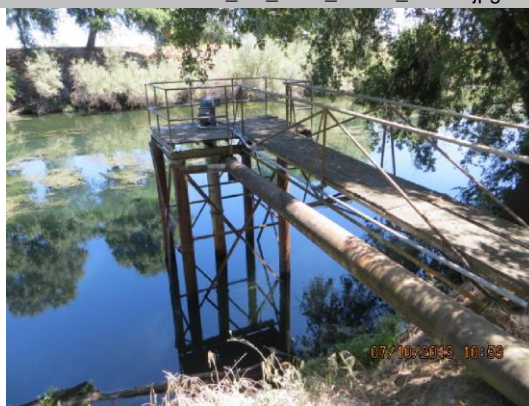
Photo 3 of 3 : UCIP\_SP\_2017\_15624\_25967.jpg

Pump on metal pier with walkway at WS toe

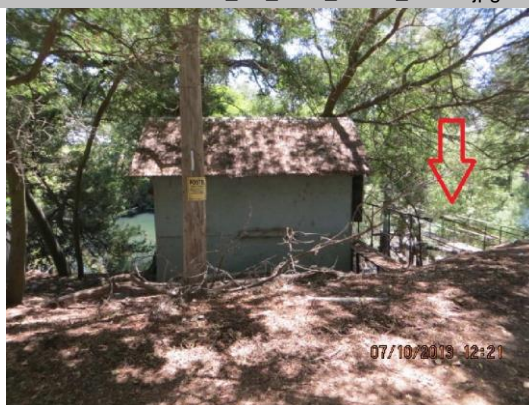
Photo 1 of 3 : UCIP\_SP\_2017\_15683\_26102.jpg

Pump on metal pier with walkway on WS slope.

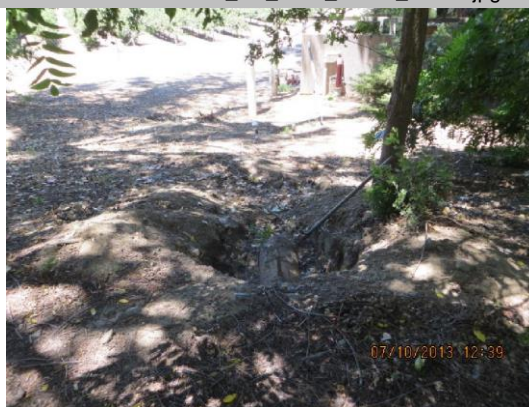
Photo 3 of 3 : UCIP\_SP\_2017\_15683\_26100.jpg

Pipe visible on LS shoulder with siphon breaker.

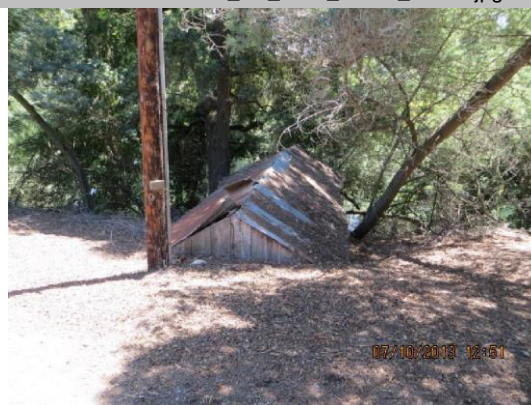
Photo 1 of 3 : UCIP\_SP\_2017\_15685\_26106.jpg

Pumphouse/concrete headwall on WS slopt.

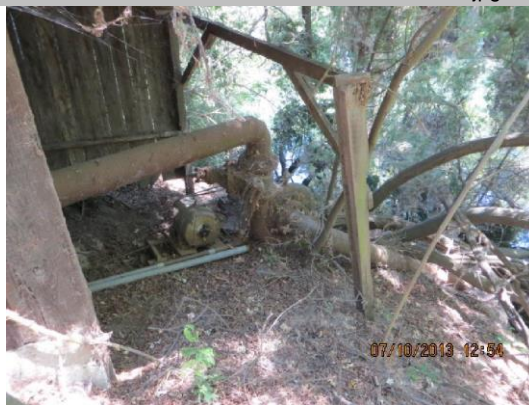
Photo 3 of 3 : UCIP\_SP\_2017\_15685\_26104.jpg

Pump and gatevalve in pumphouse on WS toe.

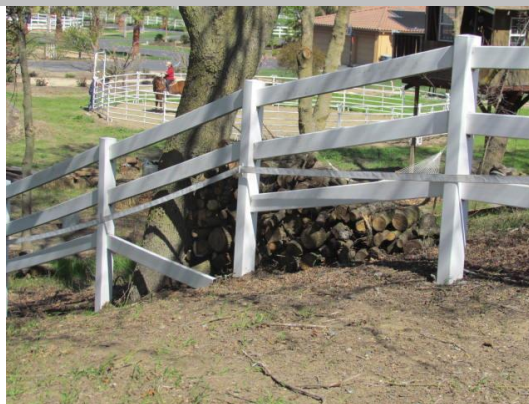
Photo 1 of 1 : SP\_2017\_RD0999\_236\_195\_20170314\_00135.jpg

Looking northeast at firewood on landward slope.

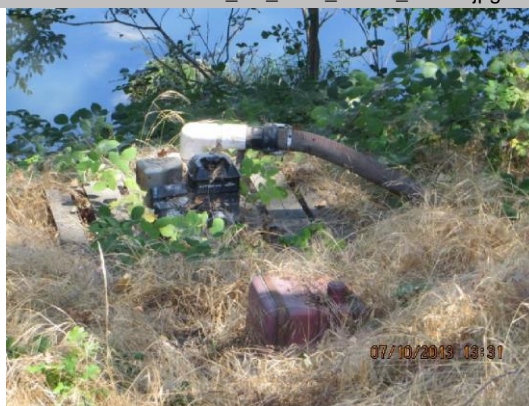
Photo 1 of 2 : UCIP\_SP\_2017\_16345\_27558.jpg

Portable pump on WS toe.
